# Manhole Inspection Summary

Manhole # S43II\_008MH

Insp Date: **3/1/10 1:37 PM**

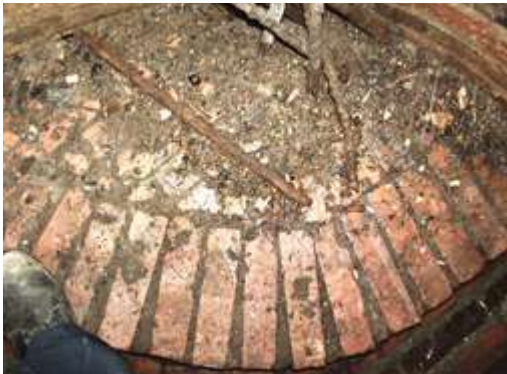
Defect 4

Condition: ☐ Sound ☐ Cracked ☐ Root Intrusion ☐ Deteriorated ☒ **Leaks** ☒ **Debris**

debris

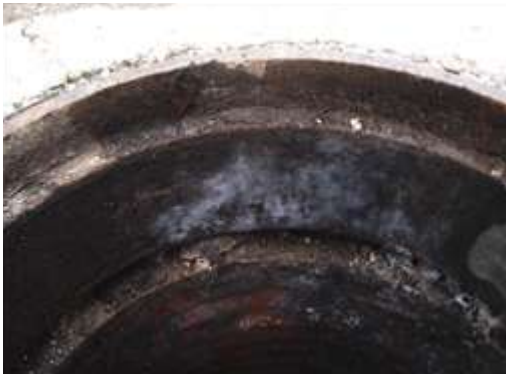
Defect 3

☒ **Leaks**

frame leaks

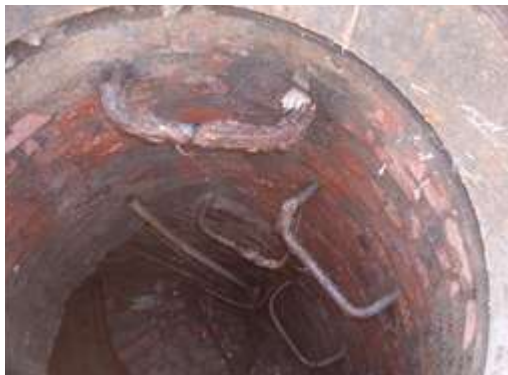
Defect 2

Condition: ☐ Sound ☐ Cracked ☐ Root Intrusion ☒ **Loose Brick** ☒ **Deteriorated**

loose bricks

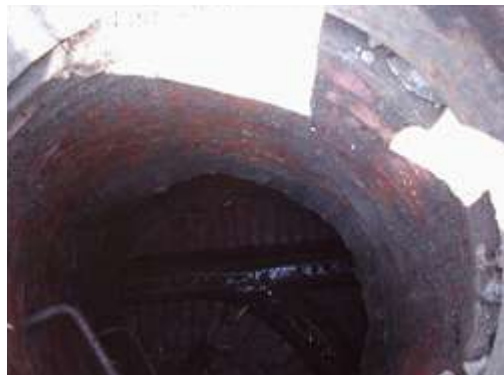
Defect 1

deterioration
